Concrete Deterioration by Alkali-Silica Reaction (ASR)

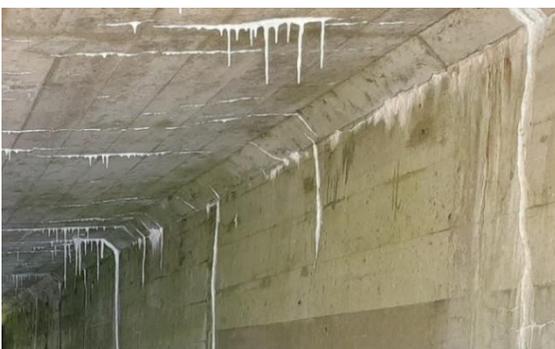
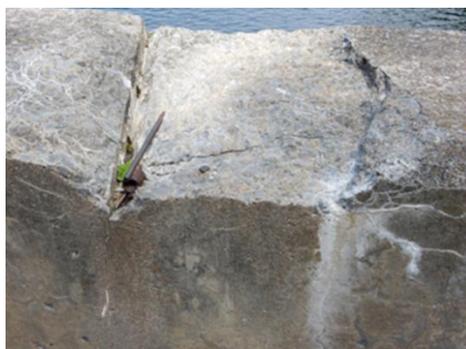
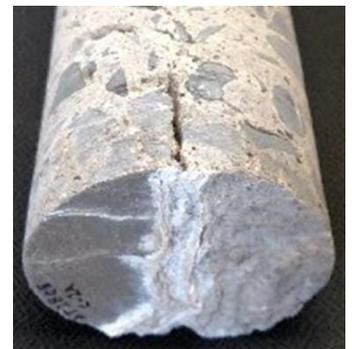
The ASR gel expands as it hydrates, causing the surrounding concrete to also expand and eventually crack due to the build-up of internal tensile stress. Over time, the gel may emanate from the cracks as a type of efflorescence and form thin coatings or thick, localized accumulations (including stalactites) on the exterior surfaces of the concrete.

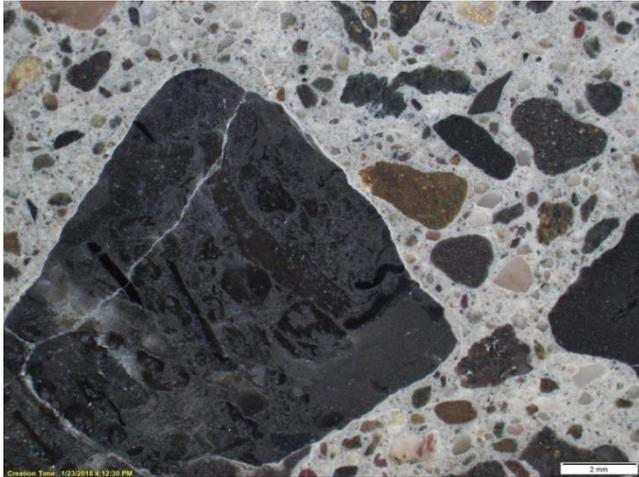
Cut and polished concrete showing white ASR gel filling a crack in a coarse aggregate particle; magnification x8.

A microscopic examination of the concrete (as outlined in ASTM C856, *Standard Practice for Petrographic Examination of Hardened Concrete*) can confirm the presence of ASR, since cracking and efflorescence may result from several different physical and physiochemical causes. The microscopic examination can also identify ASR within the concrete even before the concrete begins to crack.

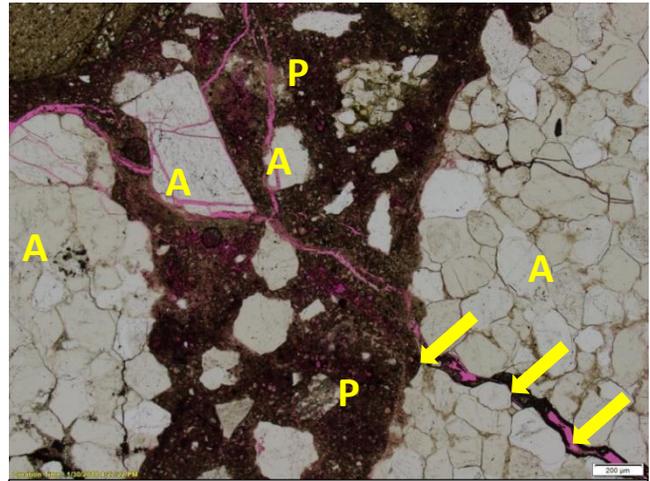
Microscopic view of cracks within aggregates (A) and adjacent paste (P) partially-filled with ASR gel (arrows); magnification x40.
