Concrete Deterioration by Alkali-Silica Reaction (ASR)

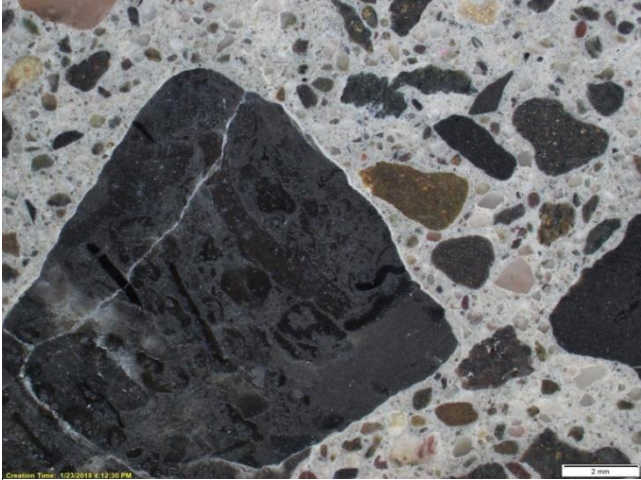
Cut and polished concrete showing white ASR gel filling a crack in a coarse aggregate particle; magnification x8.

A microscopic examination of the concrete (as outlined in ASTM C856, *Standard Practice for Petrographic Examination of Hardened Concrete*) can confirm the presence of ASR, since cracking and efflorescence may result from several different physical and physiochemical causes. The microscopic examination can also identify ASR within the concrete even before the concrete begins to crack.

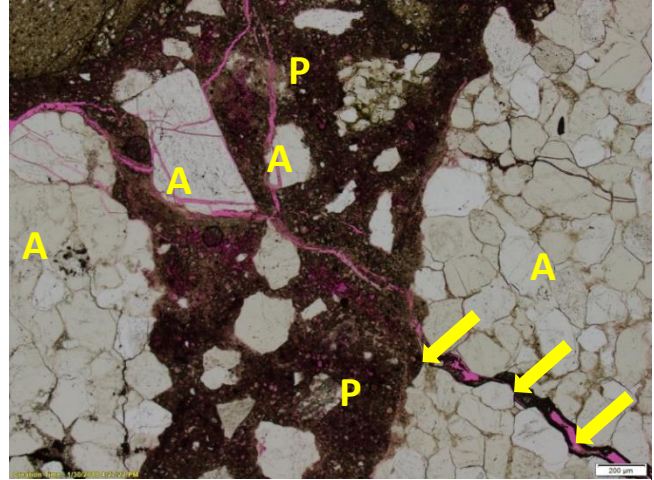
Microscopic view of cracks within aggregates (A) and adjacent paste (P) partially-filled with ASR gel (arrows); magnification x40.
