# Concrete Deterioration by Alkali-Silica Reaction (ASR)

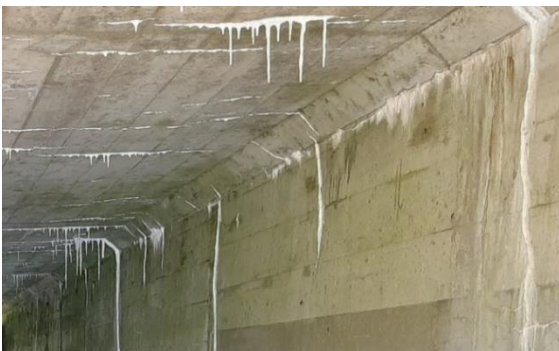
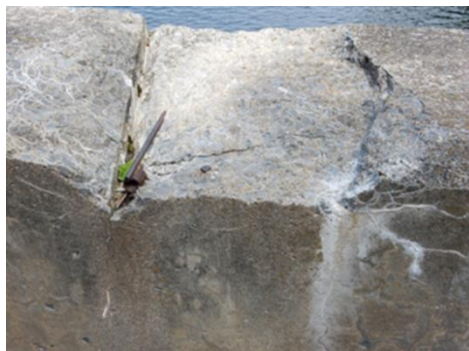
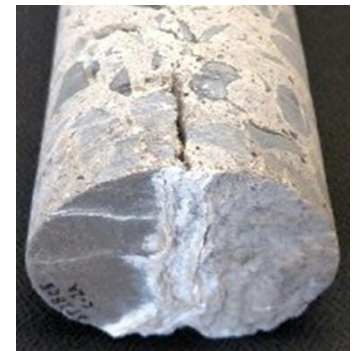
The ASR gel expands as it hydrates, causing the surrounding concrete to also expand and eventually crack due to the build-up of internal tensile stress. Over time, the gel may emanate from the cracks as a type of efflorescence and form thin coatings or thick, localized accumulations (including stalactites) on the exterior surfaces of the concrete.

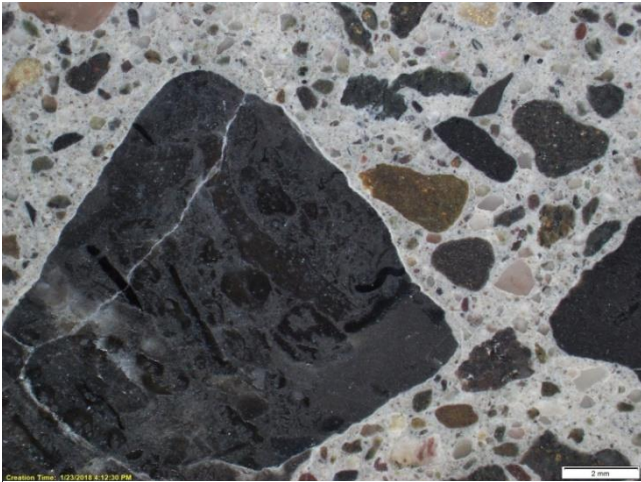
Cut and polished concrete showing white ASR gel filling a crack in a coarse aggregate particle; magnification x8.

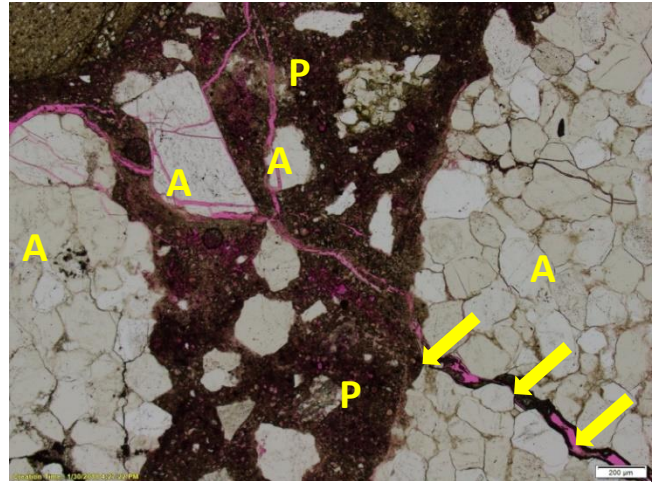
Microscopic view of cracks within aggregates (A) and adjacent paste (P) partially-filled with ASR gel (arrows); magnification x40.
