# Carbonation of Concrete and Oxidation of Embedded Steel

*Dr. Christopher R. Kelson, PhD, PG  
Senior Geologist  
Atlantic Testing Laboratories*

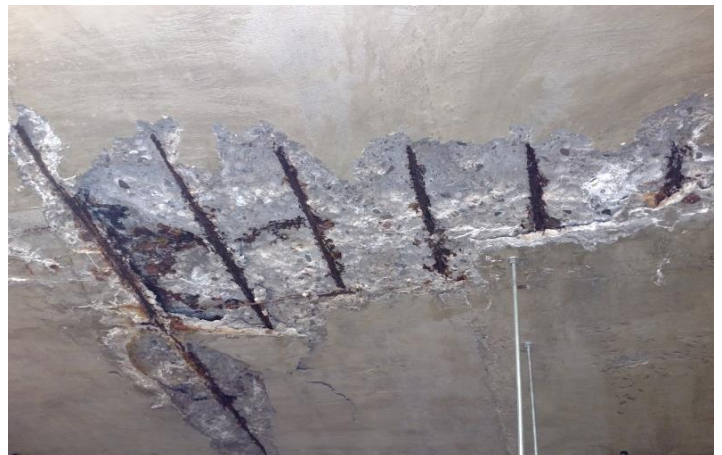
The process of carbonation physiochemically alters cement paste by decreasing its permeability and lowering its pH. The decrease in permeability renders the concrete less susceptible to the infiltration of solutions which may contain chemicals detrimental to the concrete such as deicers, acids, chlorides, and salts. Carbonation also tends to increase the compressive and tensile strength of concrete. However, carbonation lowers the pH of cement paste from ~13 to ~9 which nullifies the passivity layer that surrounds and protects embedded steel items (e.g., reinforcement, pipes, conduits) from exposure to oxygen and water. Removal of the passivity layer renders embedded steel items susceptible to

oxidation and corrosion due to the formation of secondary products such as iron oxide (rust) which causes the surrounding concrete to expand, crack, and ultimately fail.
