# Concrete Slab Delamination

**Steven N. Moore, PE**  
**Senior Engineer**  
*Atlantic Testing Laboratories*

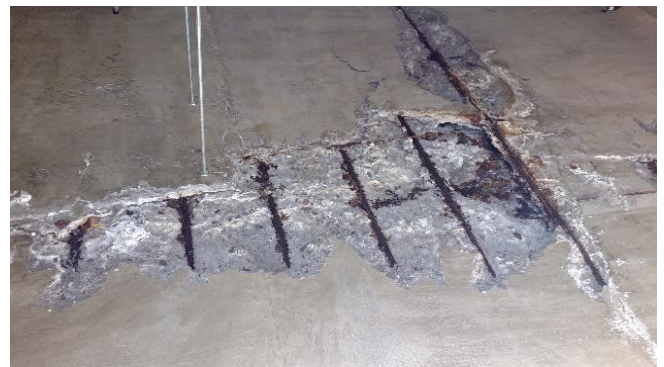
Slab delamination due to reinforcement corrosion.

Permeable subbase can also reduce the chances of surface delamination. Impermeable barriers under the slab prevent water from escaping, thus increasing the amount of water migrating upward toward the finished surface. Delamination may also be caused by corrosion of reinforcing steel near the surface. Corrosion is an expansive reaction, and radial cracks develop around the reinforcing steel, due to the build-up of tensile stress around the

corroding steel. When a layer of reinforcement is corroding, the cracks eventually become interconnected and the concrete will delaminate and spall at the surface.

Surficial delamination typically shows up soon after the concrete has cured. Corrosion delamination typically occurs in older structures exposed to chemicals or other environmental conditions. Petrographic analysis (ASTM C856) can show capillary voids left behind from bleed water migrating to the surface, and hardened air void analysis (ASTM C457) can analyze the air void structure in hardened concrete. Additionally, reinforcement corrosion can be evaluated and mapped out using half-cell potential measurements, as outlined in ASTM C876, Corrosion Potentials of Uncoated Reinforcing Steel.
